Site Observation Report

| DATE: | Oct 1, 2010 |
| PROJECT NO.: | 205174 |
| PROJECT NAME: | Noorvik Clinic |

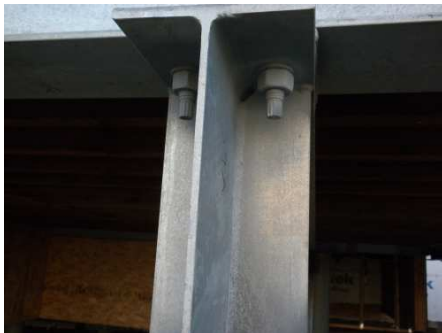
- I observed a mix of standard A325 High Strength Bolts and LeJeune twist-off type bolts in the visible structural steel connections. None of the LeJeune bolts had been tightened to the point of twisting off the tension-indicating stems. However, pretension is not required. The structural drawings call all connections out as “snug tight”, which does not require these bolts to be twisted off, so the bolts are all okay as installed.

LeJeune Bolts – stems not twisted off

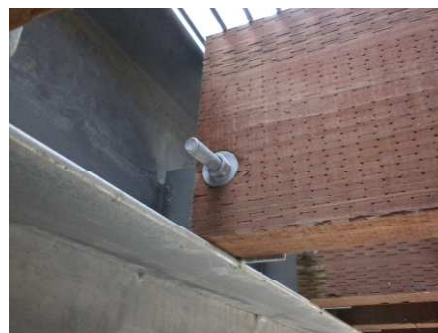
3x10 cut flush – reduced bearing area

- Near Grid D and plan east of Grid 5, 3x10 joists support the exterior deck at the first floor and frame into a C15 at the top of the drive-in ramp. This connection is detailed as 12/S5.2. I noted that the angled cut at the end of the 3x10 joist was not done. Instead, the

joist was cut straight off at the edge of the C15 flange, largely reducing the bearing area of these joists. Due to the possibility of vehicle traffic in this area, a fix may be required and if so, will be forthcoming.

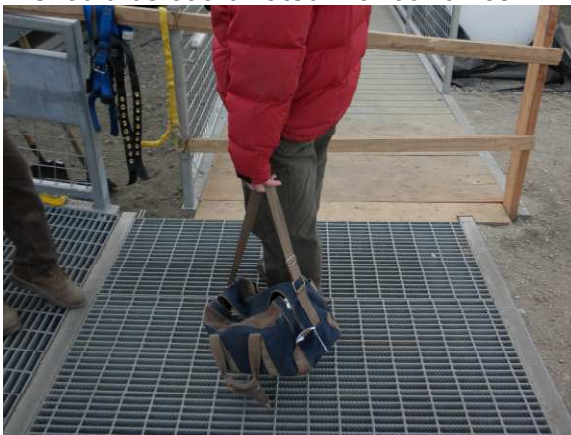
- There was a discrepancy between the existing deck and building locations shown on the original plans and what was encountered in the field. This resulted in a misalignment of the two portions of ramp landing plan north of Grid B and east of Grid 5. I did not see any structural issues with the current setup of this condition, in which the two bottom sections of ramp landing were simply not connected. Any proposed fix to realign these ramp landings should be coordinated with our office.

Ramp Landings Misaligned

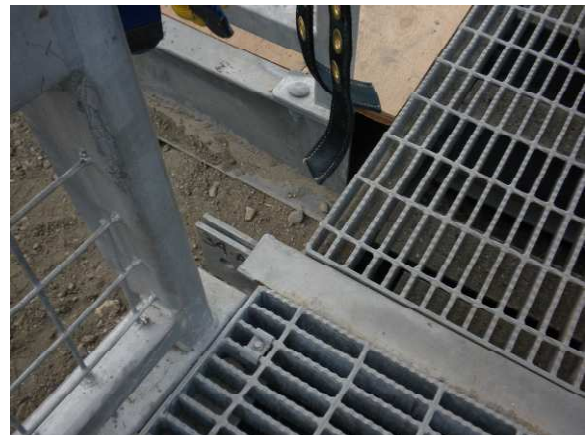
Ramp Landings not connected – OK as constructed
